### Old St Giles 3: blue plaques and history

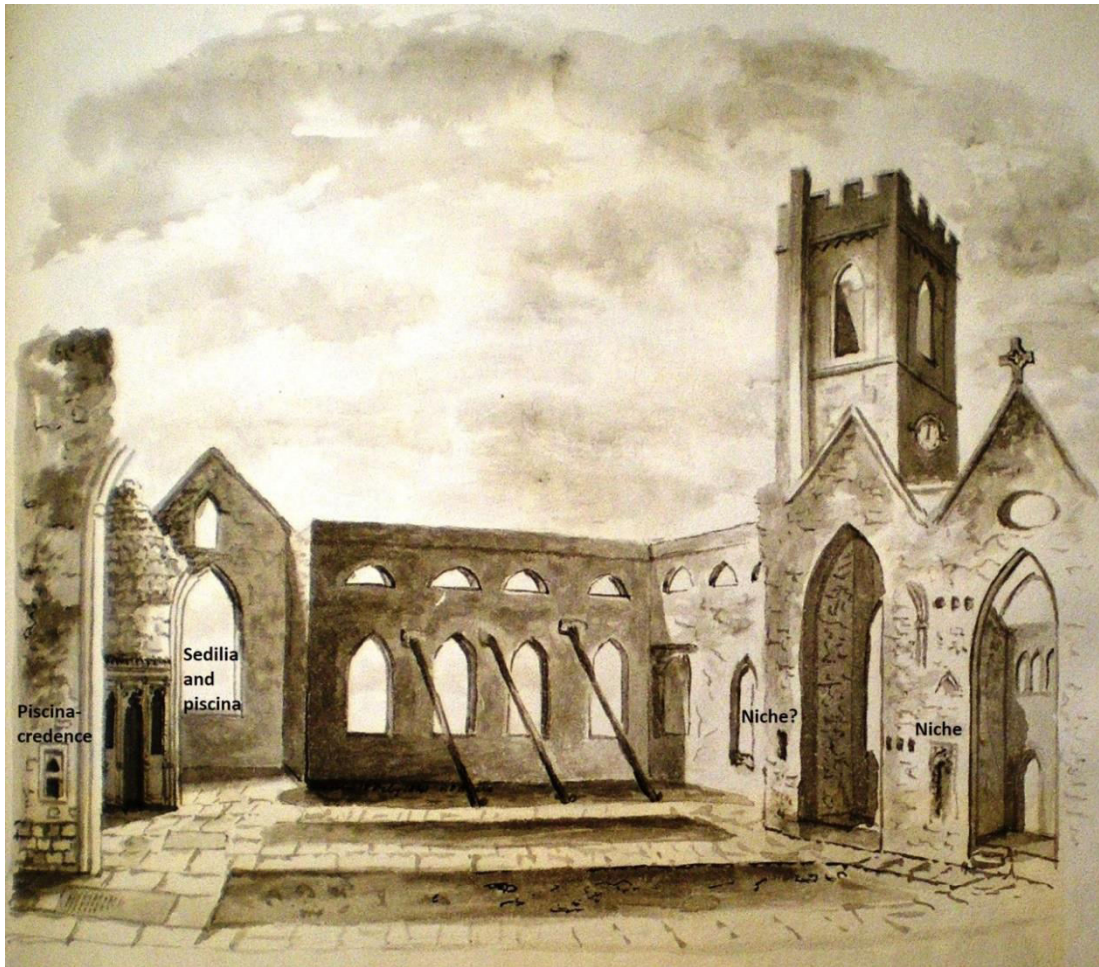
Figure 6. The burnt-out interior of the church (© British Library Board, Crach.1.Tab.1.b.1.)

They can be seen in position in a sketch of the burnt-out interior of the church done immediately after the fire. The sedilia in the chancel and Johnston's "piscina-credence" in the St Nicholas Chapel are clear. We don't get a view into what remains of the Lady Chapel (at the back left) but two other niches can be seen, one (possibly) on the west wall of the nave, the other on the west wall of the north aisle. The latter, from its appearance, could well be the one that Johnston did not give a location for, the one on the left of his drawing.

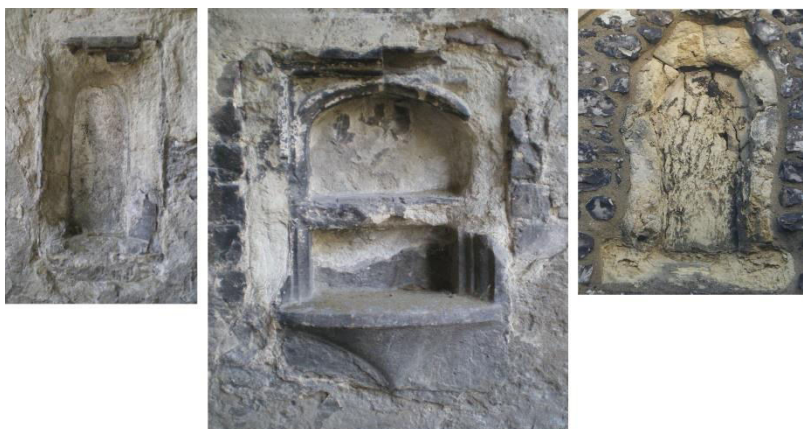
The structure in Benhill Road, then, was built as a home for these medieval survivals, and that is where Johnston saw them. The remains of the niches, dreadfully eroded, are still there: the one from the Lady Chapel outside above the entrance, the one probably from the north aisle inside to the left, and the piscina-credence inside to the right.

Figure 7. The three medieval niches, arranged as in Johnston's drawing

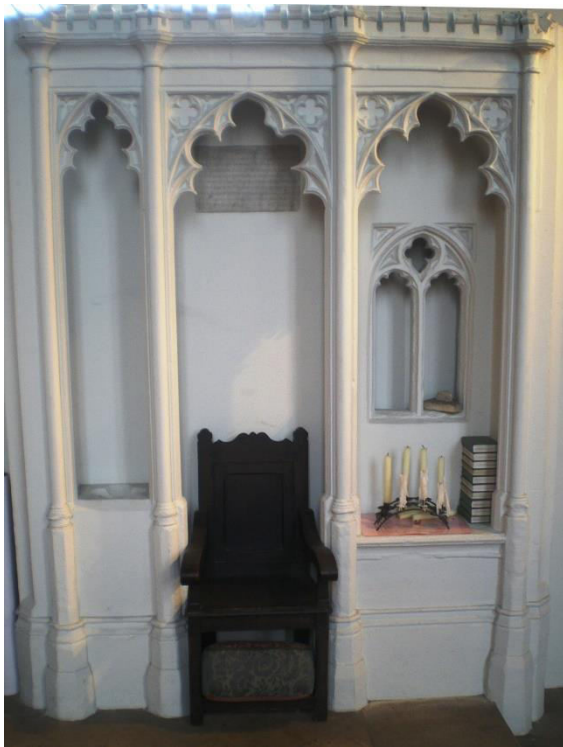
When Johnston saw the sedilia in the early twentieth century he was surprised by how well they were preserved. In 1916 they were retrieved from Benhill Road by William Isaac Shard, and installed in the chancel of Scott’s church, where they are to this day, having left their still-visible, clear outline on the back wall of their previous shelter.

*Figure 7. The sedilia and piscina as they are today*
