## Old St Giles 2: the church that burned down

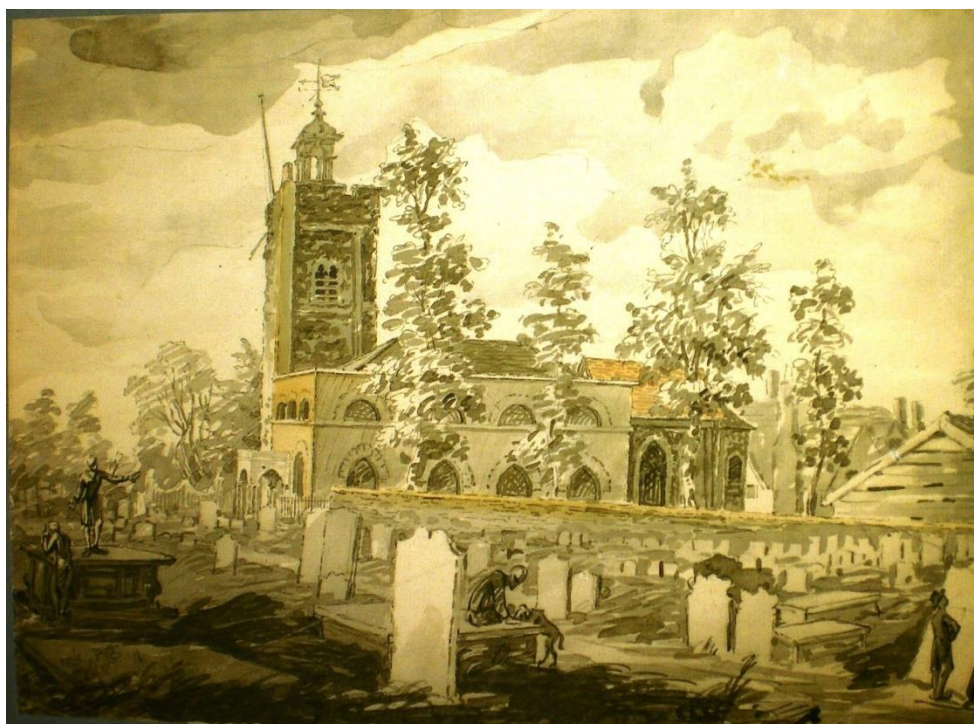
Figure 7. Old church from the SW 1787-1798 ( courtesy(Southwark Local History Library)<sup>12</sup>

tower was rebuilt.<sup>13</sup> This included replacing the earlier housing for the bell serving the clock with a more slender and ornate wooden gothic structure. The accounts suggest that this was to do the same job as its predecessor but it seems that the actual bell housing was set lower down, more or less impossible to see from ground level.

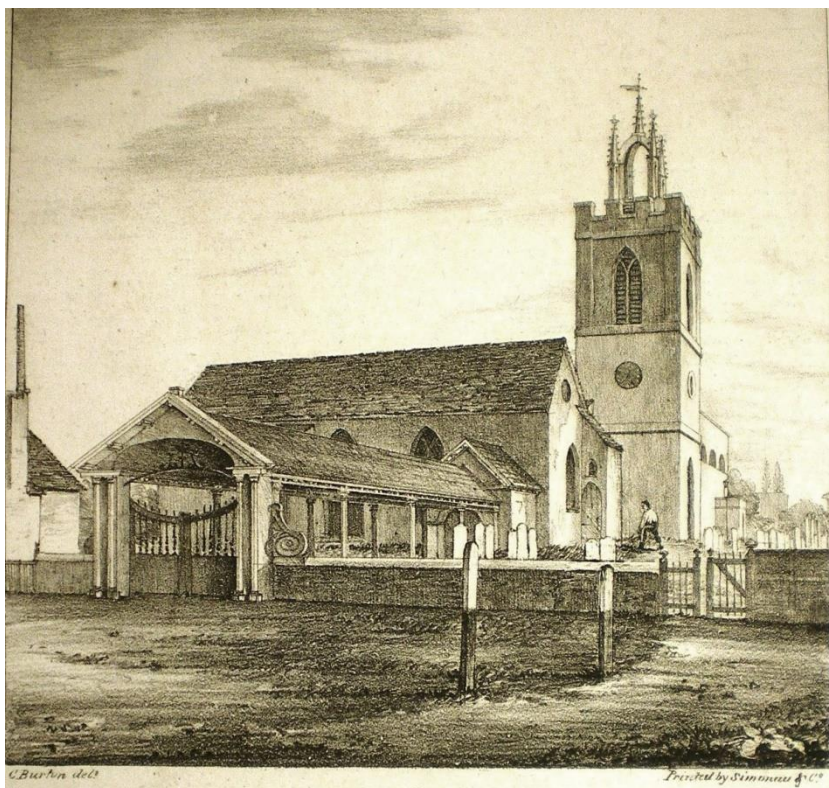
Figure 8. Old church from the NW, early 1800s (courtesy Southwark Local History Library)

All the windows, including those in the 1786 extension were refashioned into a uniform style with plain gothic arches and mullions which, on the basis of the tradesmen's bills, must have been made of wood; and the outside walls were stuccoed and painted. By the end of 1801, including refurbishing the tower, the Vestry had spent more than £1,300, much more, that is, than the cost of the 1786 extension.<sup>14</sup> A year or two later an awning, or covered way, was built to join the north porch to the churchyard gate. Figure 8 shows the results of all this work. The remade windows are most clearly seen in the tower, which now has three crenellations instead of two. The 1786 extension can be seen in the distance and the grammar school building, again, on the left. The awning, which one might imagine to have been rather a pleasant feature, only lasted about twenty years.<sup>15</sup>
